AFRL-RX-WP-TP-2008-4045

U.S. AIR FORCE EFFORTS IN UNDERSTANDING AND MITIGATING THE EFFECTS OF "NDI MISSES" (PREPRINT)

Nondestructive Evaluation Branch Metals, Ceramics & Nondestructive Evaluation Division

JUNE 2007

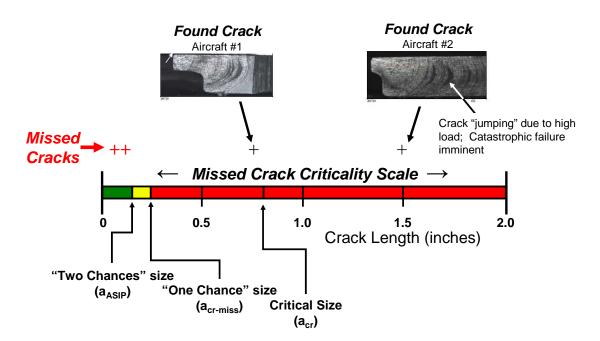
The significance of an NDI miss is illustrated in Figure 6 which describes two missed crack events on USAF trainer aircraft. On two separate aircraft, cracks were found in wing skins with lengths that were approximately equal to a_{cr} and 2a_{cr}, respectively. Upon detection of these cracks, the components were removed from service, the cracks broken open, and fractographic examinations made. Evidence on the crack surfaces pointed to instances of high loads which caused rapid crack growth approaching catastrophic failure. Despite the long lengths of the cracks, catastrophic failure did not occur because these aircraft were not flown on missions that subjected the structure to loads sufficient to cause catastrophic failure (even though such loads were within the operational spectrum of the aircraft).

Figure 6. Two cracks taht were missed on two USAFseparate trainer aircraft were eventually found but not until they were of sufficient length to threaten structural integrity and safety.

Analyses, conducted after the cracks were discovered, showed that the cracks had initially been missed during inspections conducted when the cracks were smaller than a_{ASIP} . Subsequent inspections resulted in additional misses. Thus, as illustrated by this example, the significance of NDI misses or missed cracks is that such events may result in cracks growing long enough to lead to catastrophic failure of safety-of-flight components which, in turn, would lead to the loss of an aircraft.
